**W A R D E R S '
 C O T T A G E S (fmr)
 Fremantle, Western Australia**

DUE DILIGENCE REPORT

**Prepared by
 National Trust of Australia (WA)**

**For
 Department of Housing**

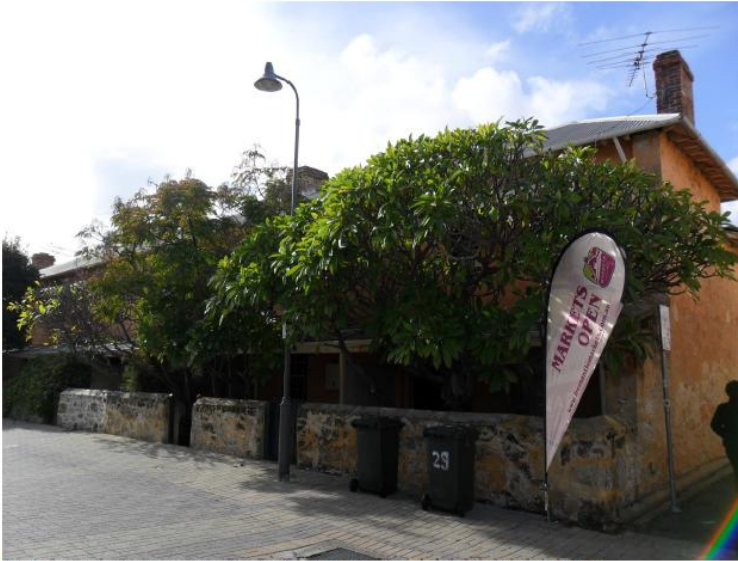
Photo 5: View across Henderson Street Mall of the front and south side of W1 adjacent to the laneway entrance to the Fremantle Markets.

W1
Extract from 'Fremantle Warders'
Cottages (fmr) Conservation Plan'
Kelsall Binet Architects for Department
of Housing, July 2011, p72

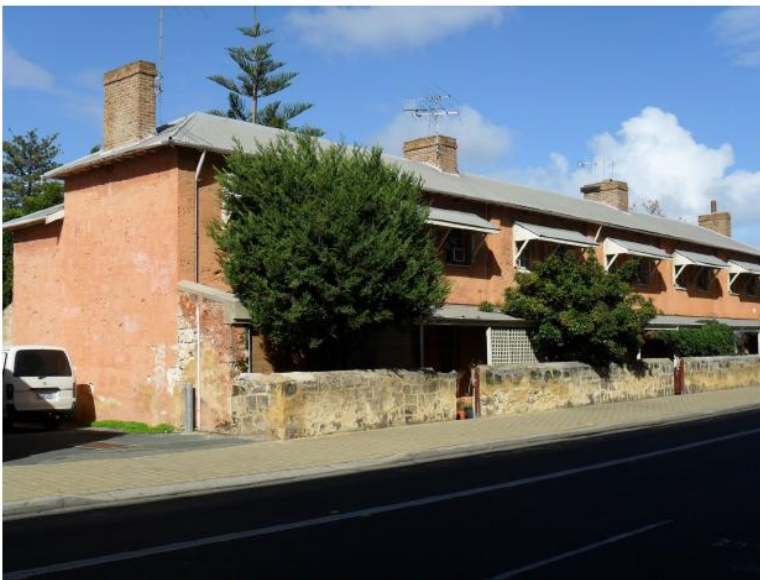
Photo 9: View across Henderson Street of the north and west elevations of W2.

W2
Extract from 'Fremantle Warders'
Cottages (fmr) Conservation Plan'
Kelsall Binet Architects for Department
of Housing, July 2011, p74

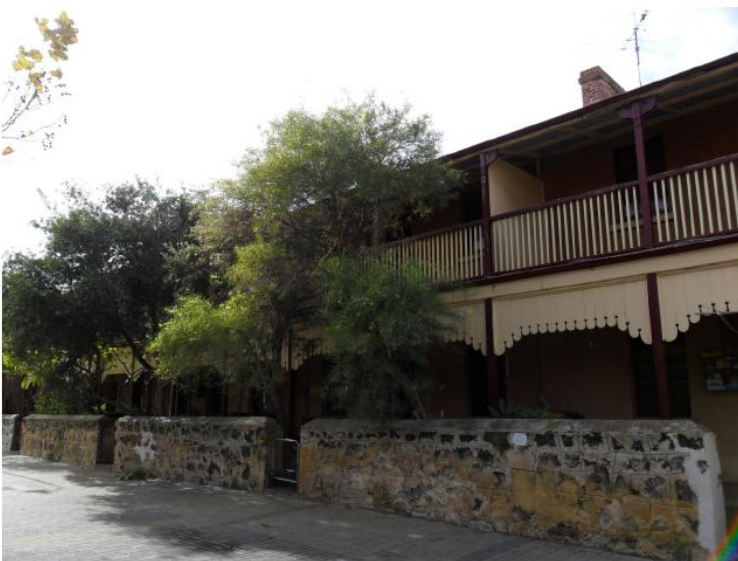
Photo 3: View across Henderson Street Mall of W3 partially obscured by plantings in the small front yards behind the low front limestone wall.

W3
Extract from 'Fremantle Warders'
Cottages (fmr) Conservation Plan'
Kelsall Binet Architects for Department
of Housing, July 2011, p71

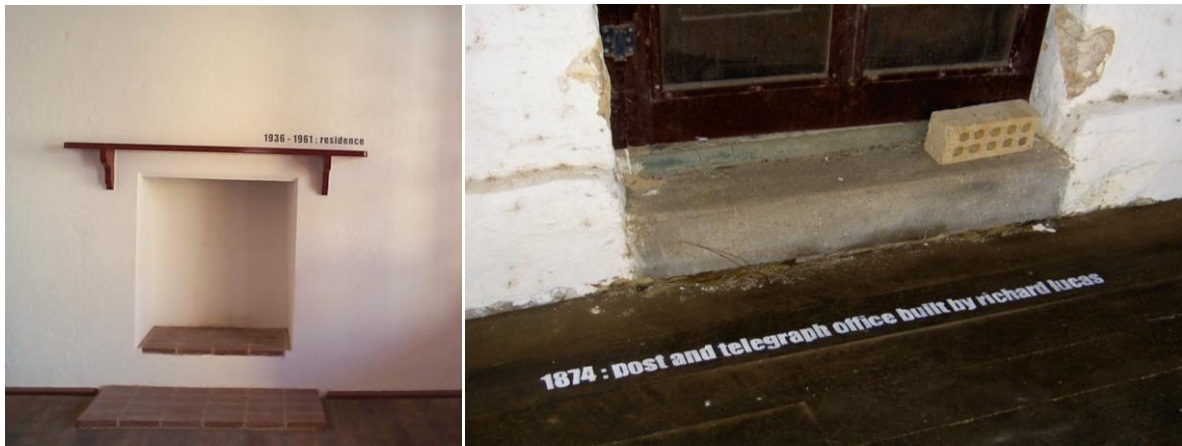
Graffiti labelling technique
Central Greenough

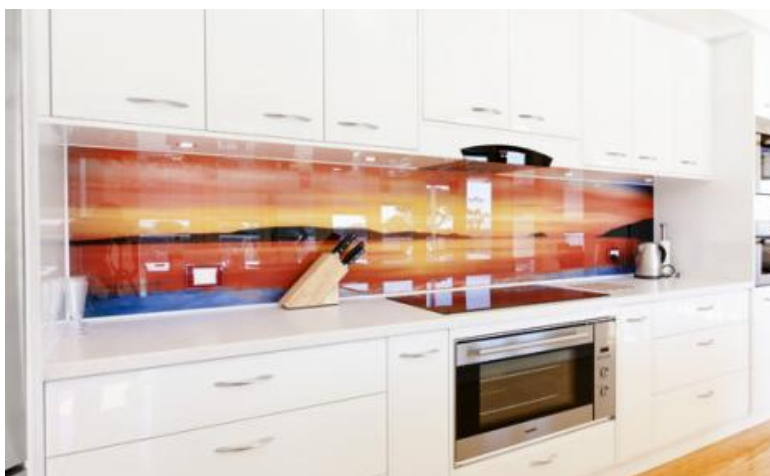
Glass splashbacks in kitchens

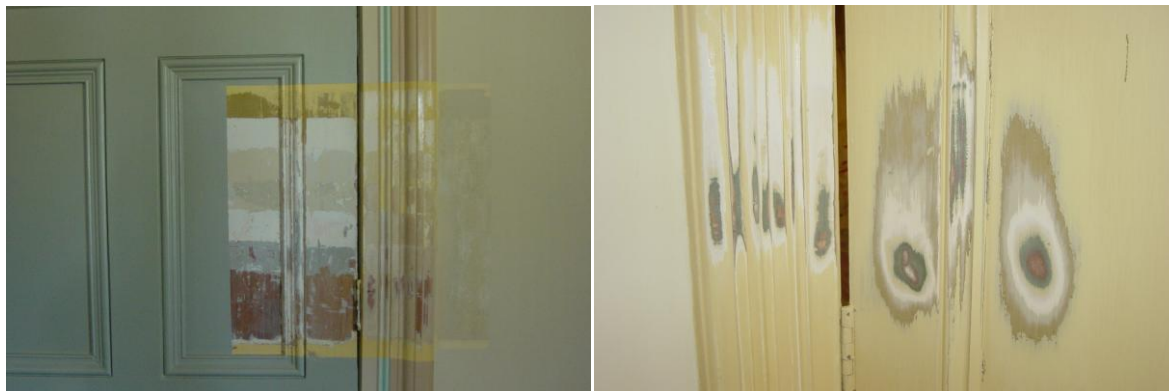
Paint ladders & scrapes reveal previous colour schemes
National Trust of Australia (WA) Head Office - The Old Observatory, West Perth
